## Site Inspection Report Summary

**Property Address:** 6231 PA-88 Finleyville, PA 15332

**Inspection Date:** 06/10/2020

## **Photo Report of Koteles Garage**

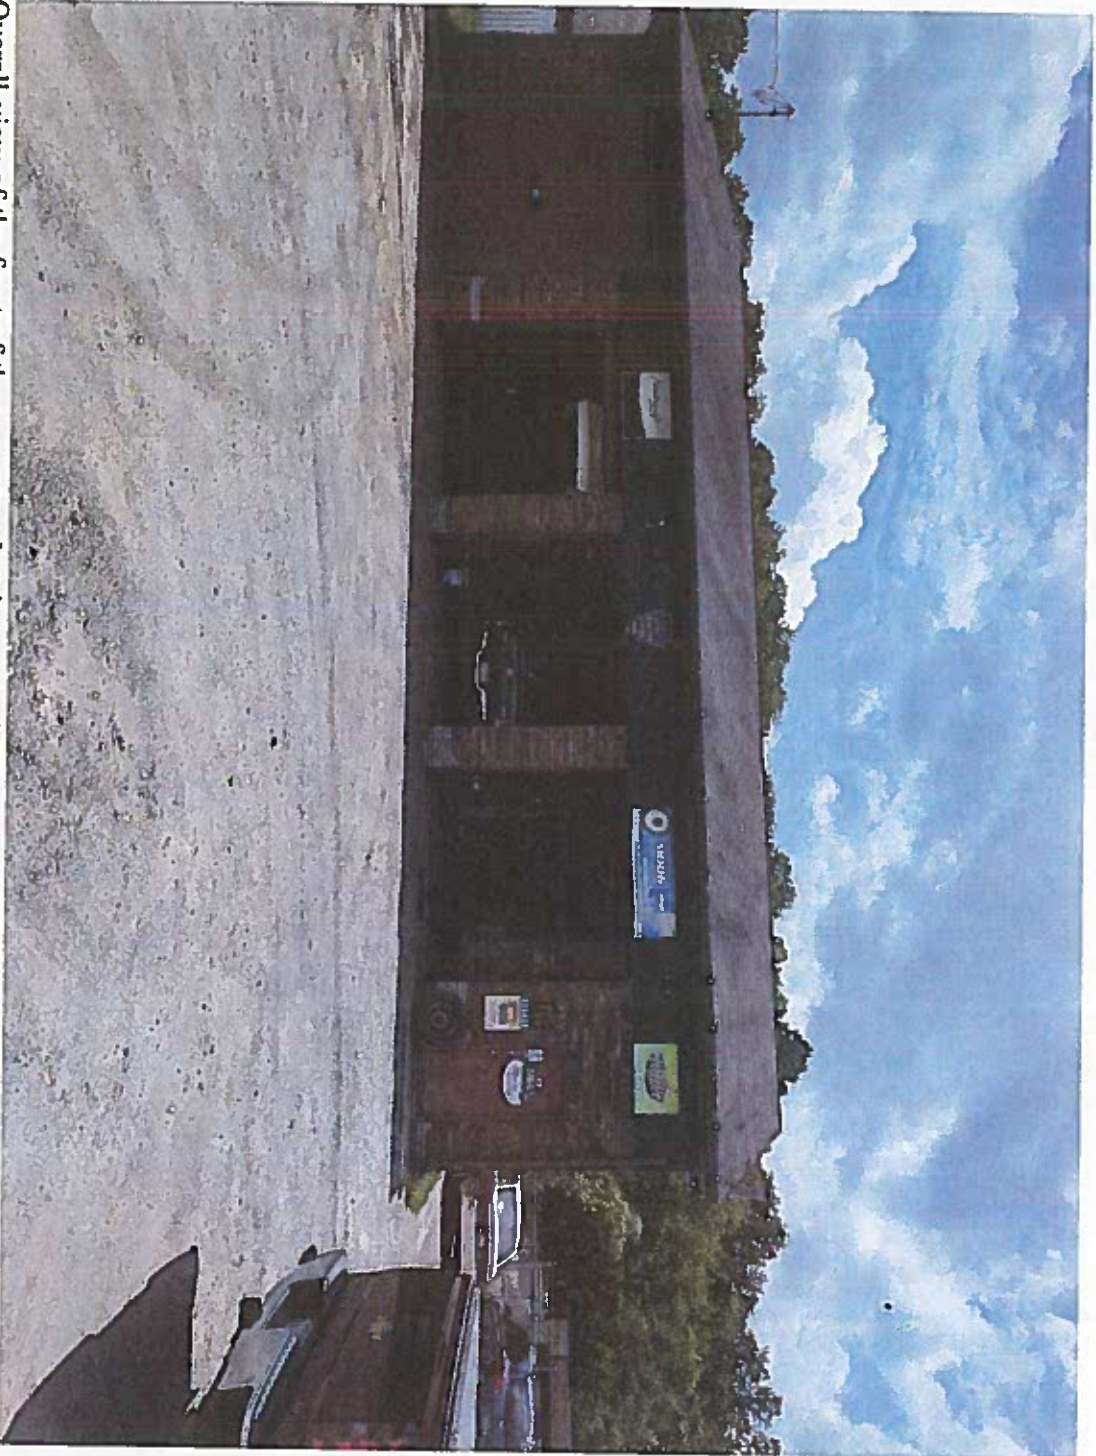
Overall view of the front of the property. Lot is unpaved. The gravel is thin. Parking spots are unpainted. Exterior lights were not confirmed to be operational during the site visit.

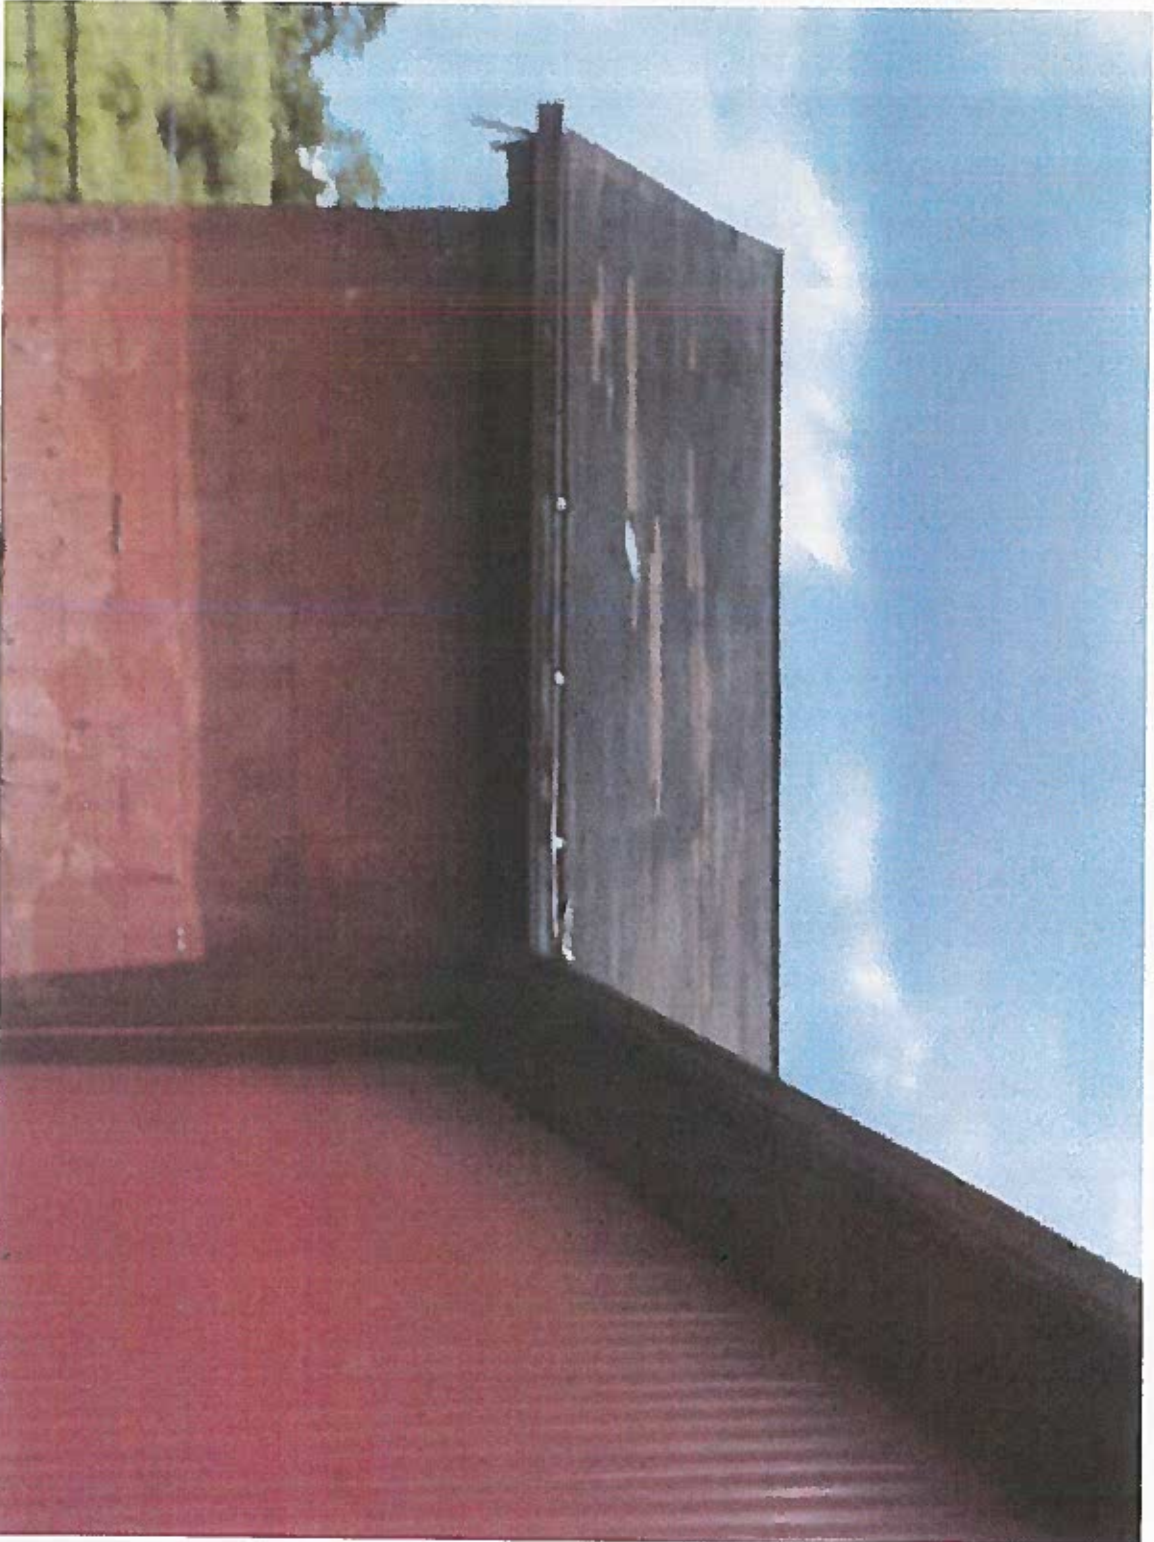
Extensive roof shingle wear and tear is evident from a rear view of the building facing towards PA SR-88

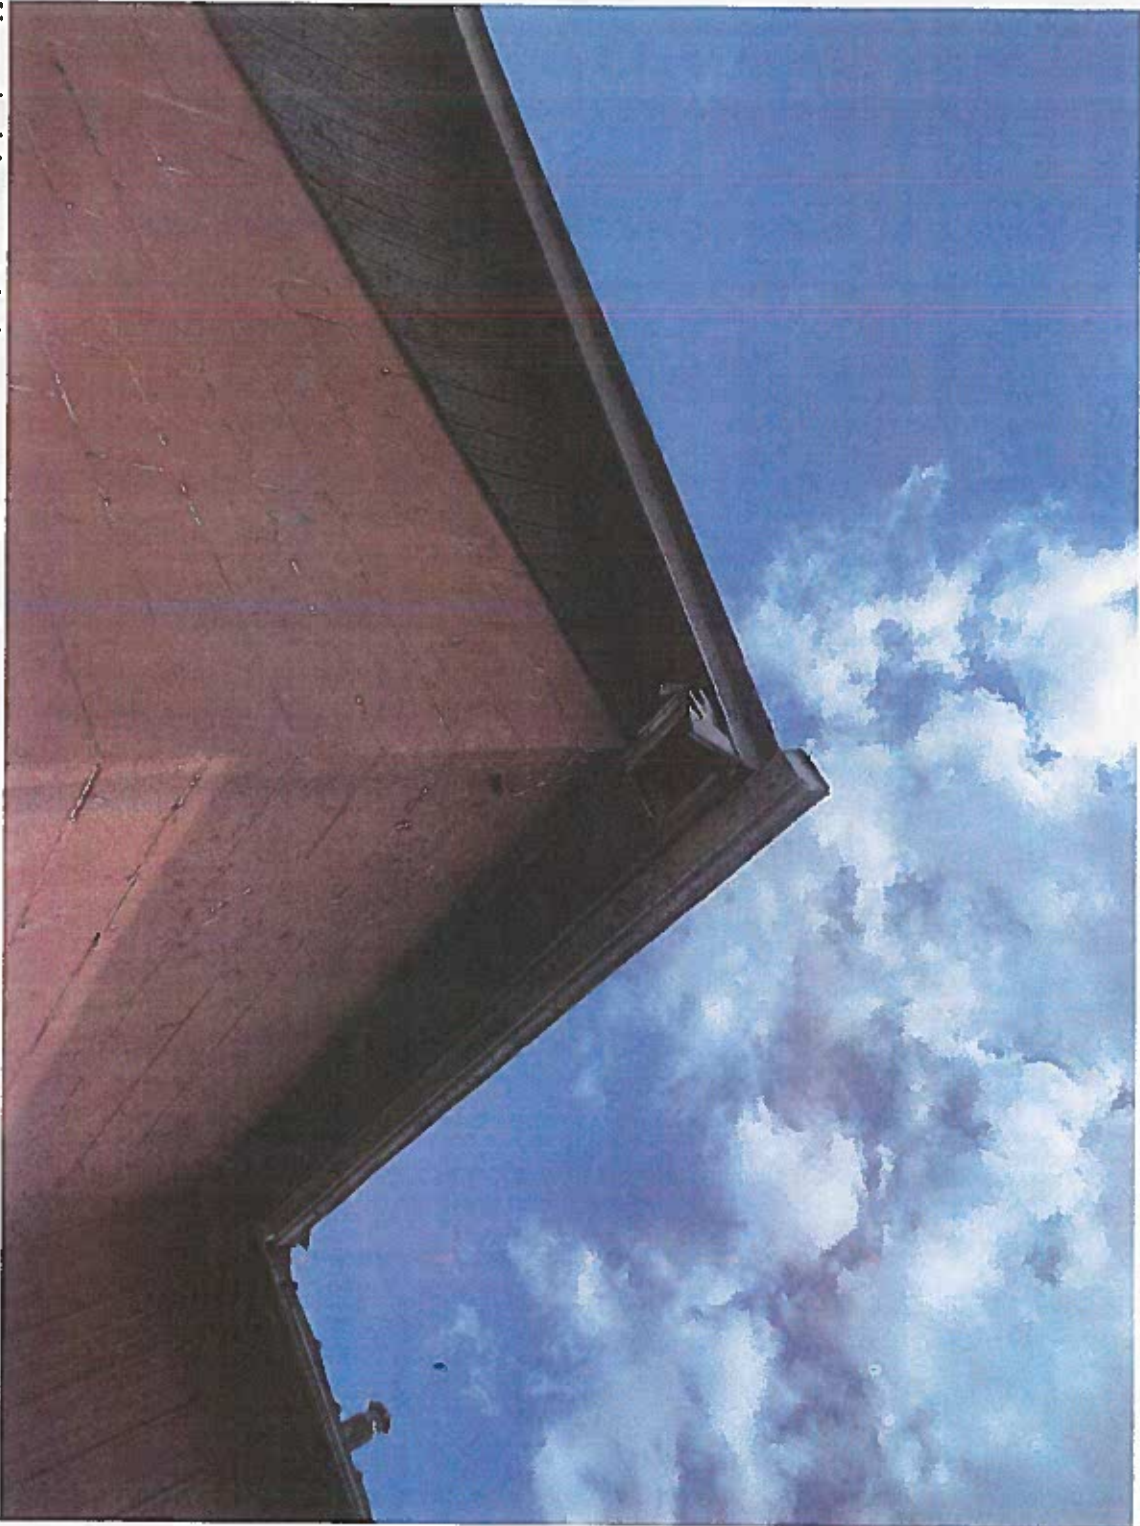
Unrepaired damage at the lower corner of the roof.

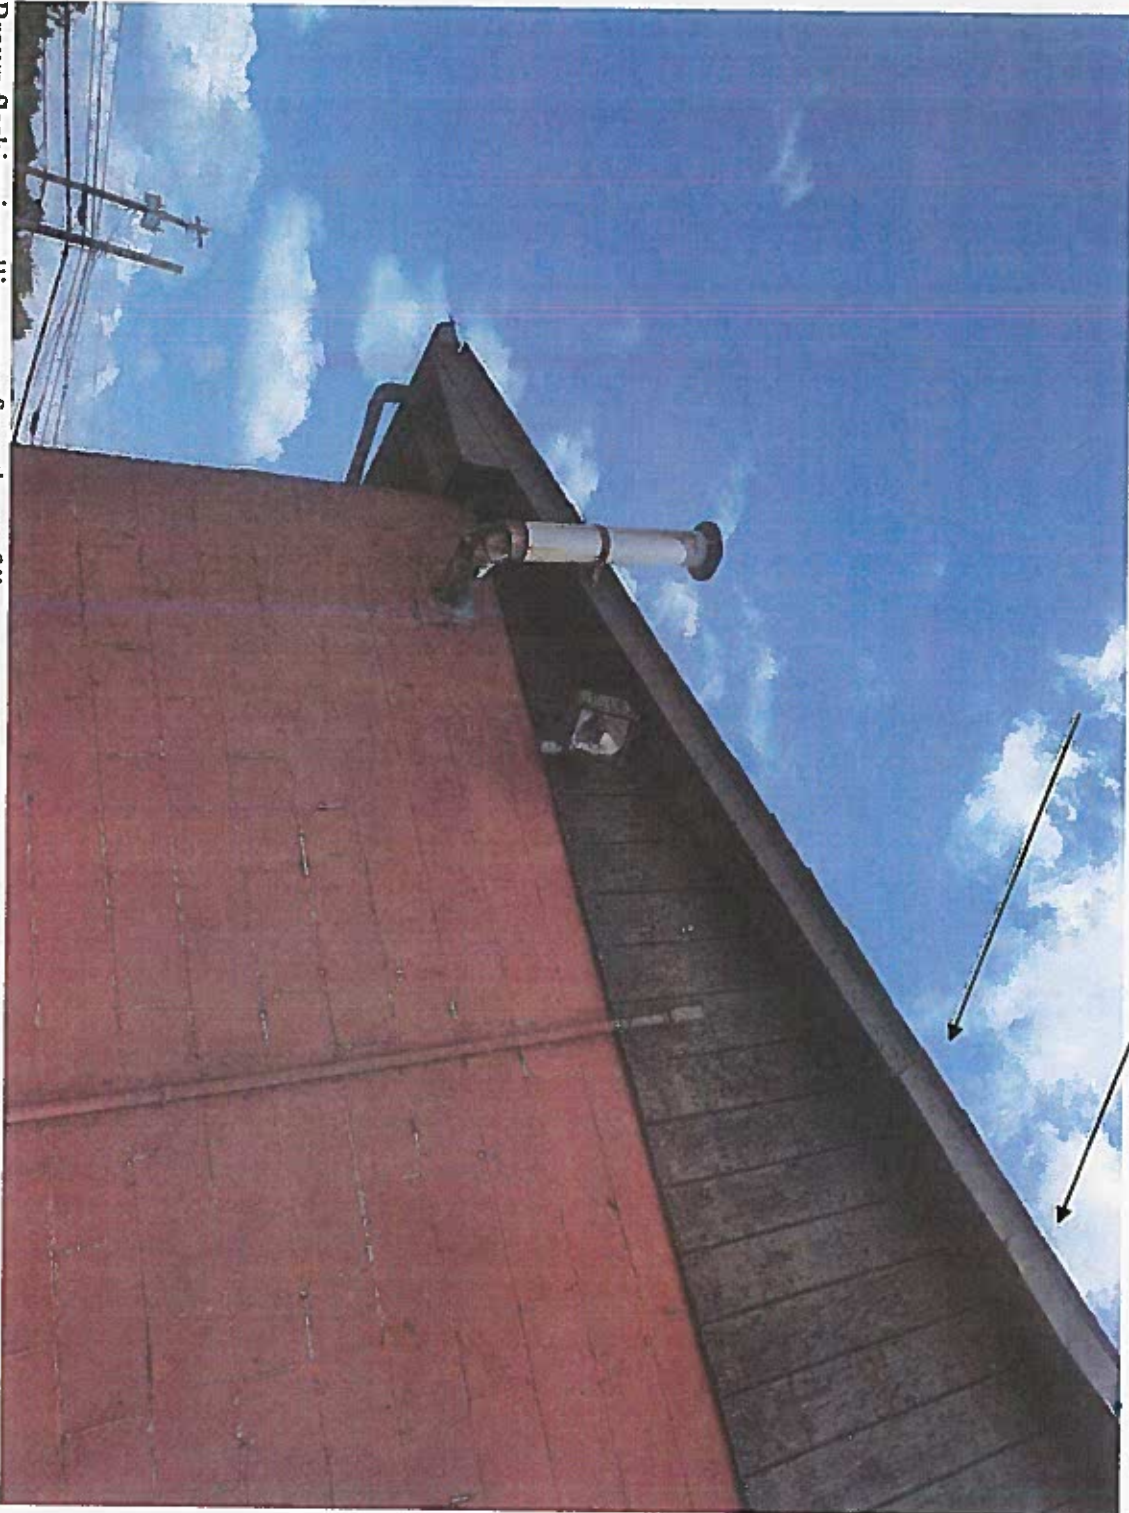
Brown flashing is pulling away from the roof line

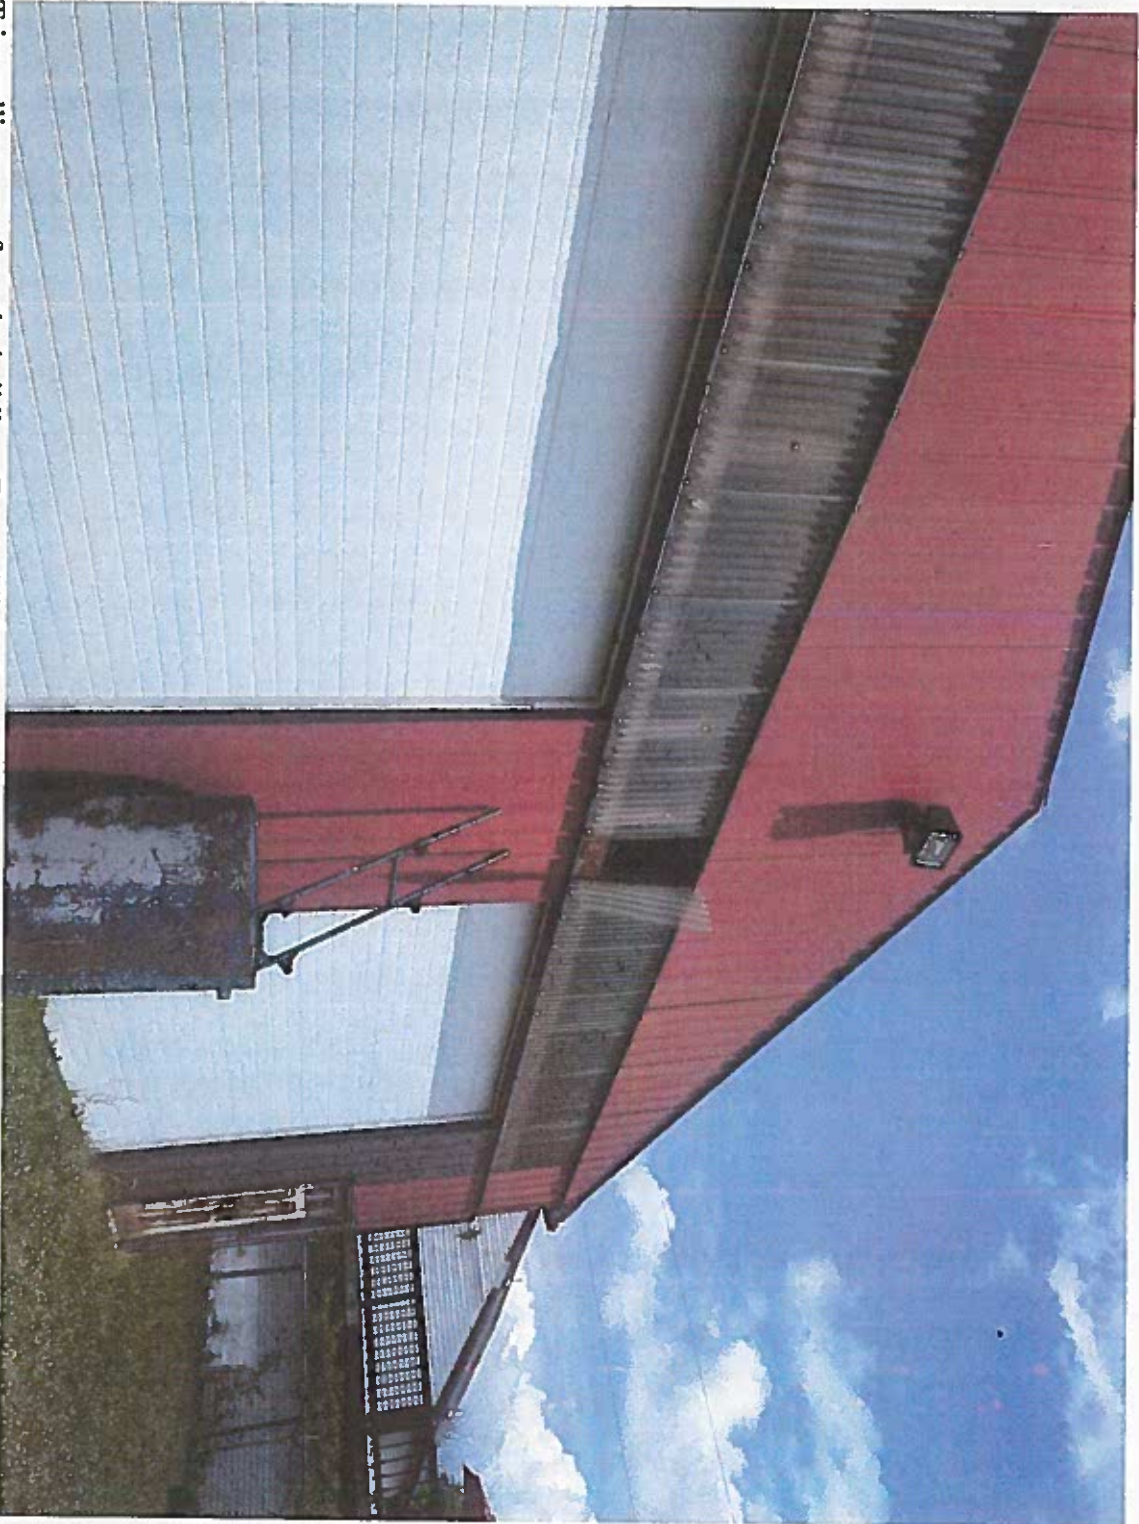
Trim pulling away from the building. External light above the trim was not confirmed to be operational.

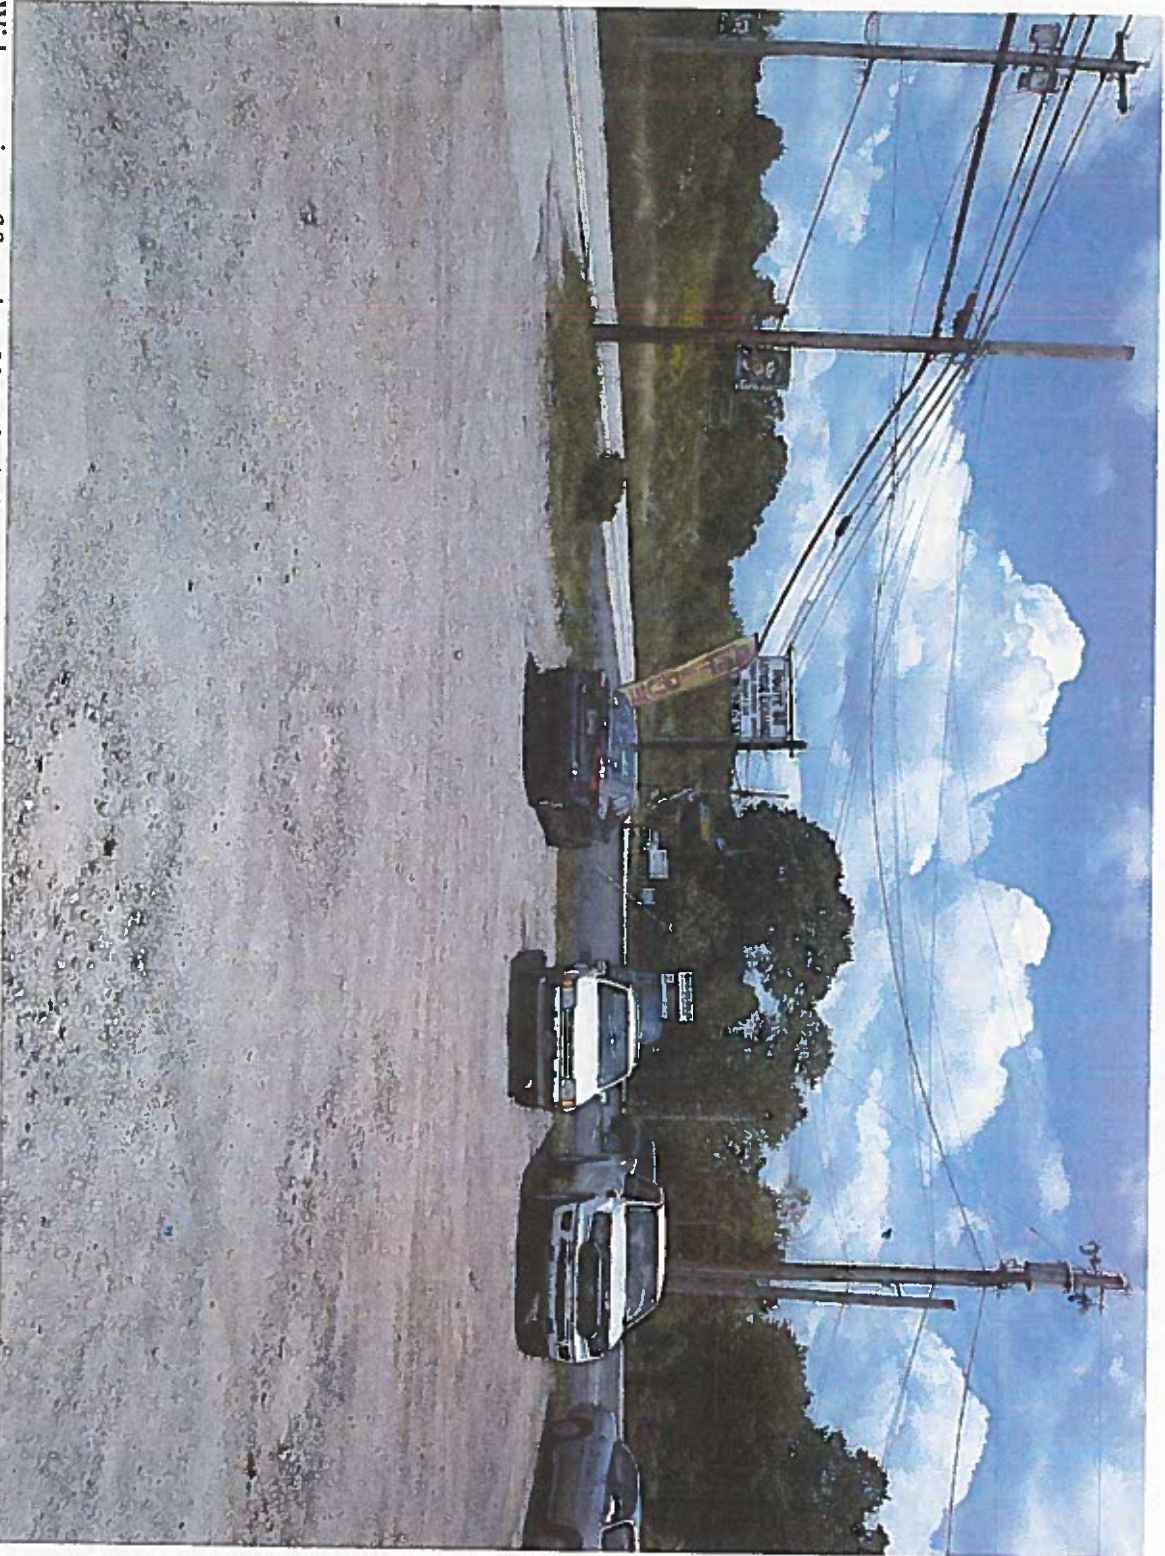
I observed that the automotive repair facility parking lot was mostly unpaved and lacked a contiguous impervious surface. (Impervious surface being defined as a parking lot constructed of asphalt, concrete, and / or cement). The surface material of the parking lot was primarily gravel. However, the gravel was noted to be thinly distributed throughout the parking lot. Potholes and ruts in the parking lot were clearly visible. The few areas of the parking lot that had impervious surfaces had observable damage due to cracking.

Wide overview of front lot. Note the holes, ruts, and defects in the parking lot.

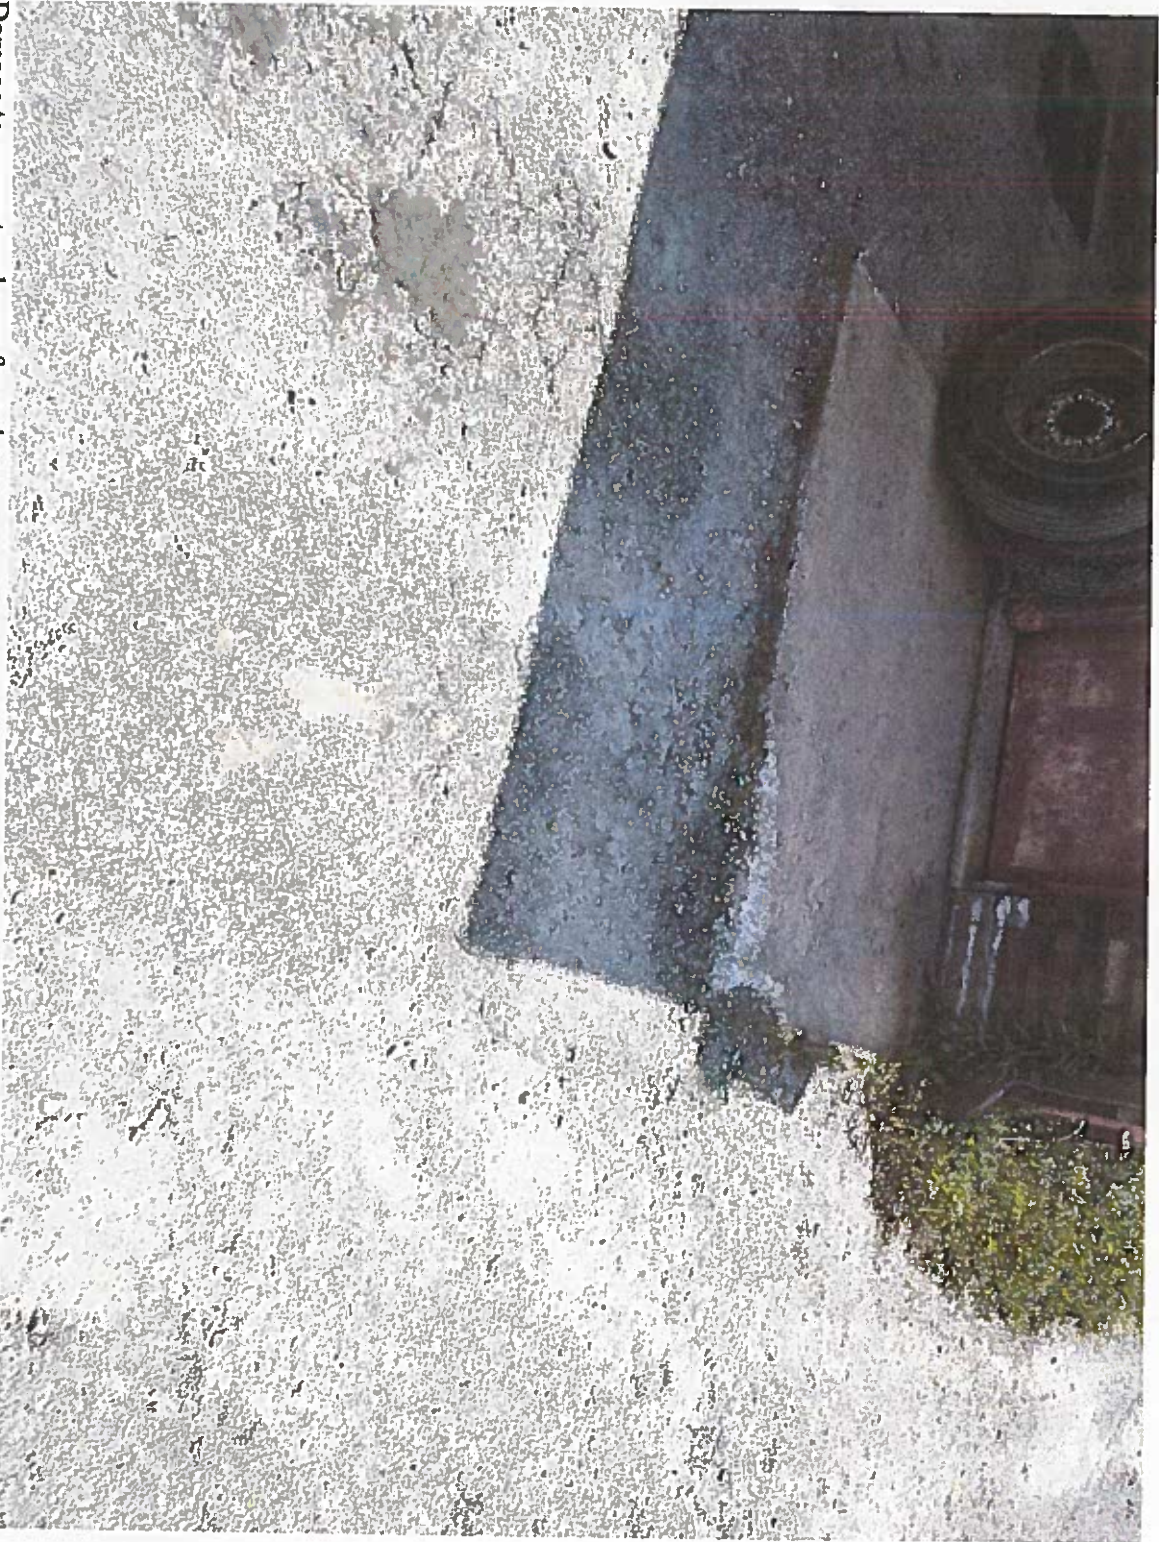
Damage to cement pad near front door.

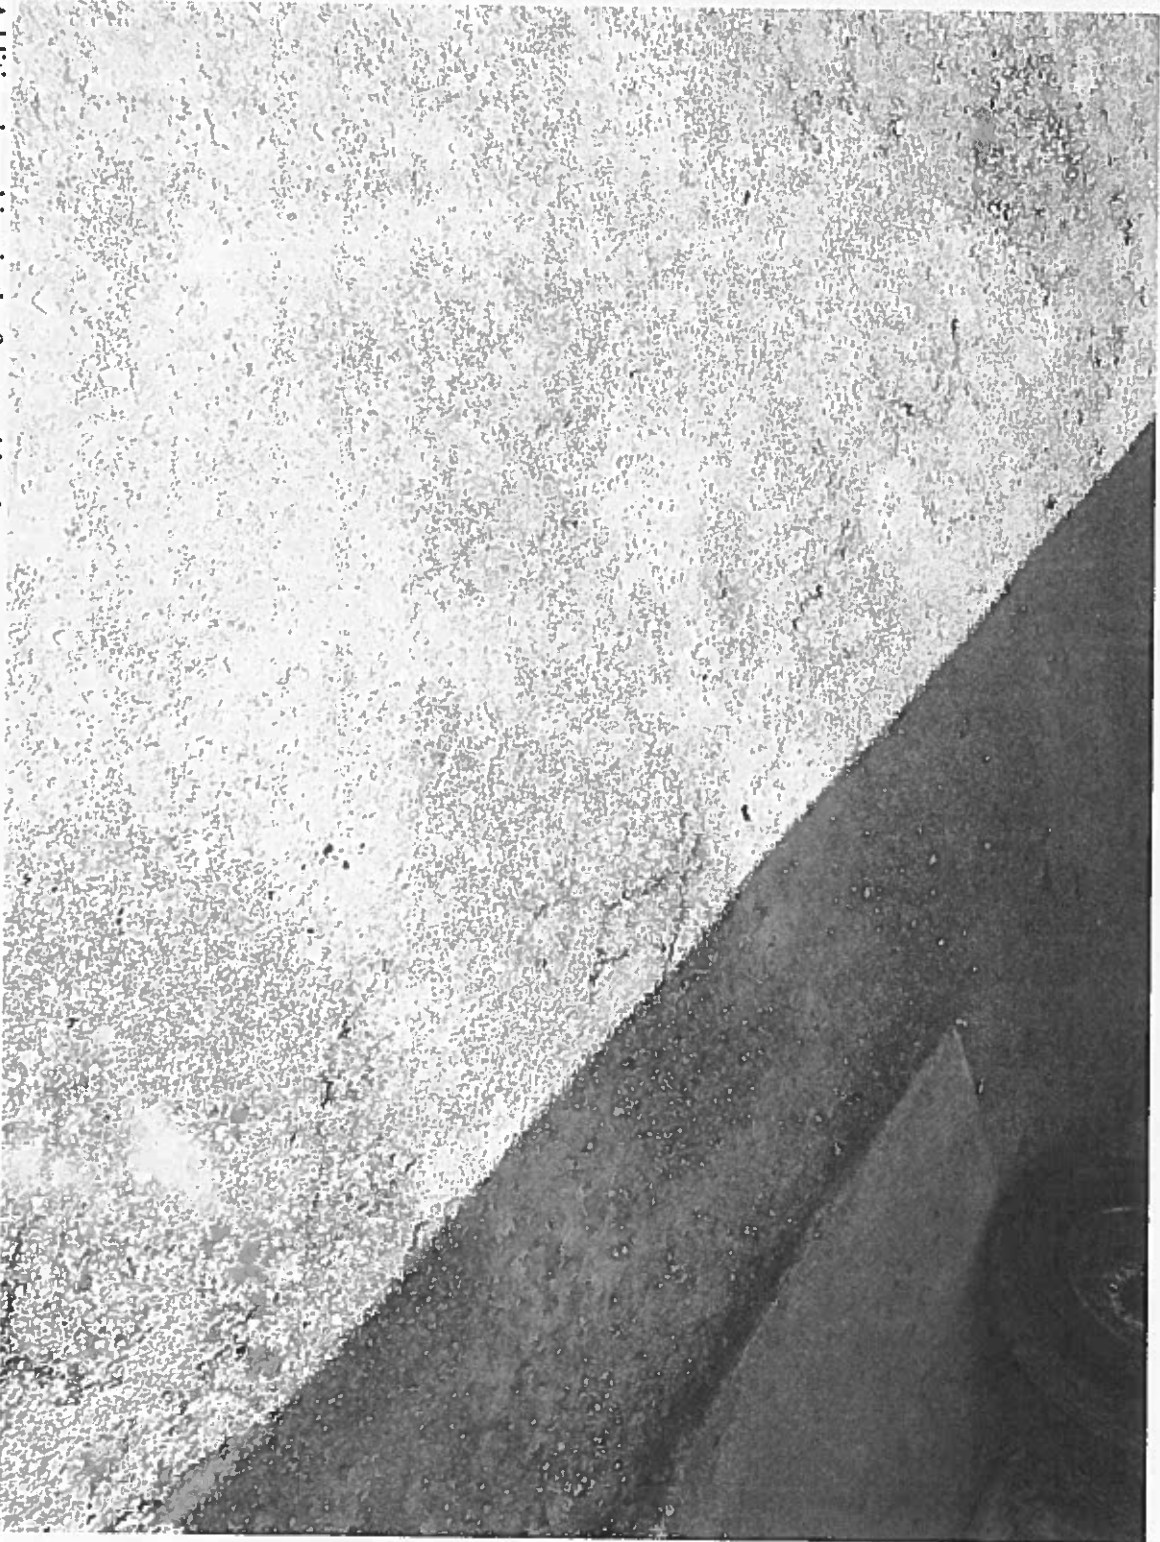
Additional cracking in the front parking lot.

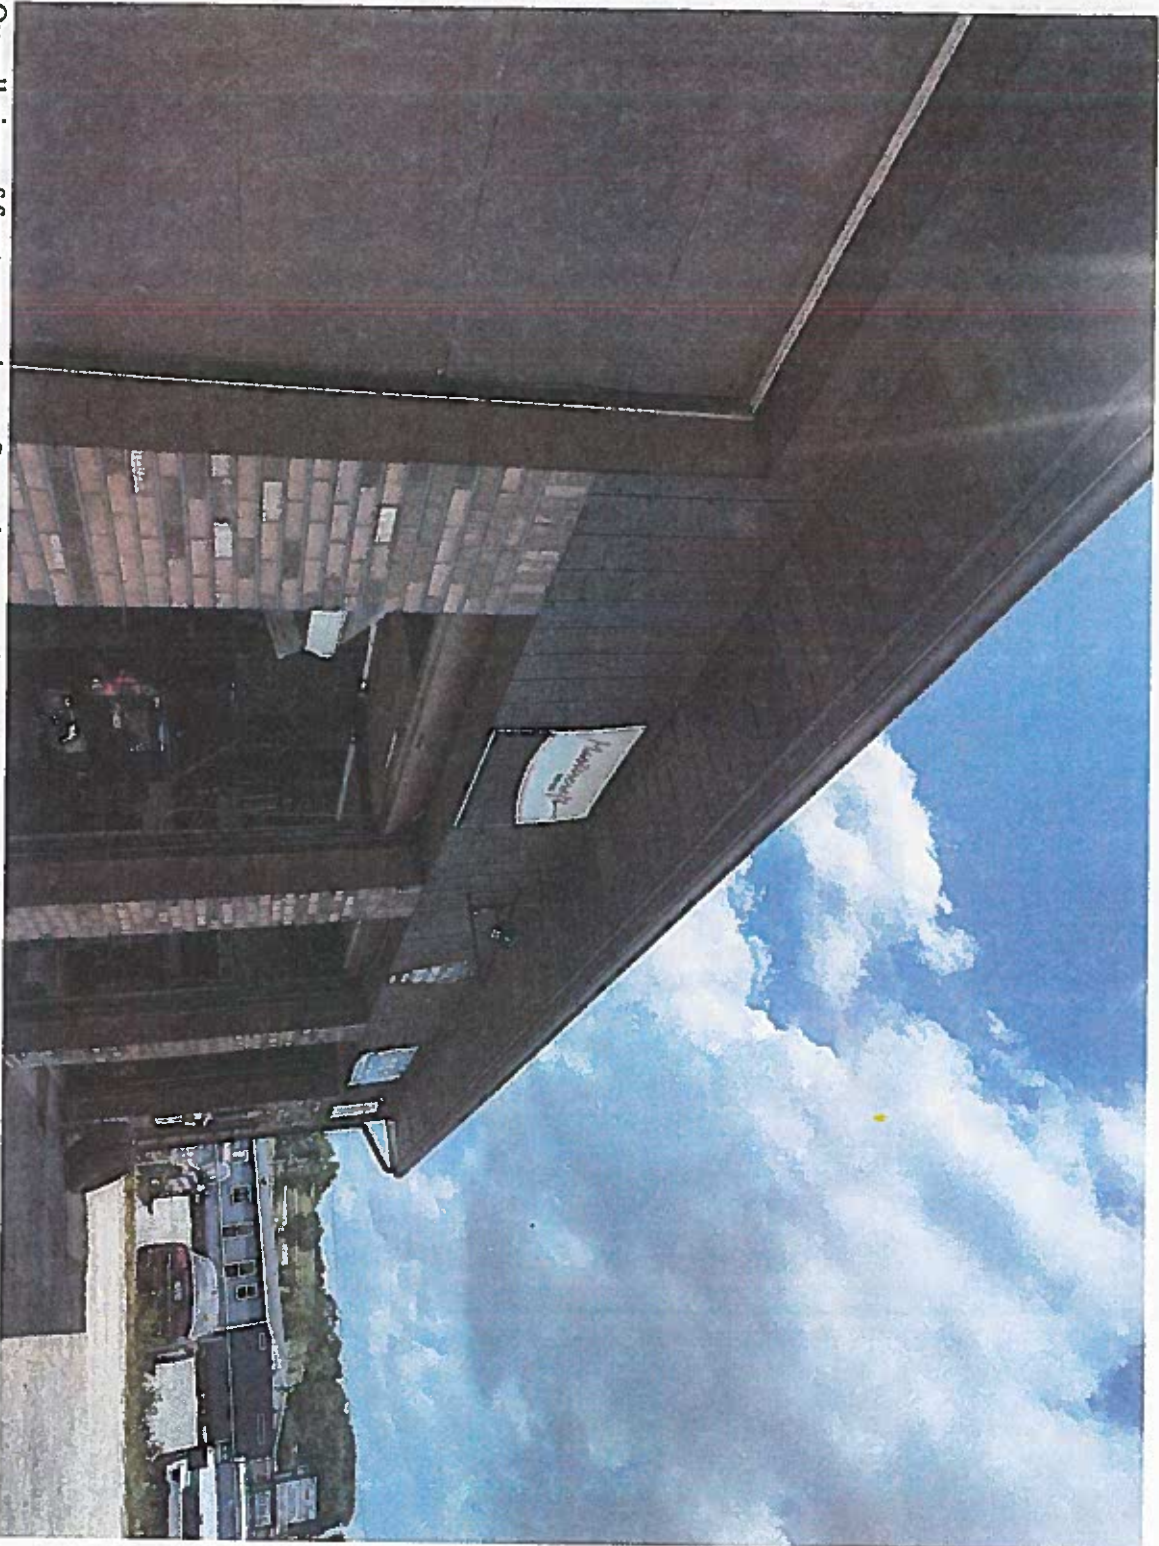
Overall view of front garage bays. Some damage at lower portions of brick pillars can be seen.

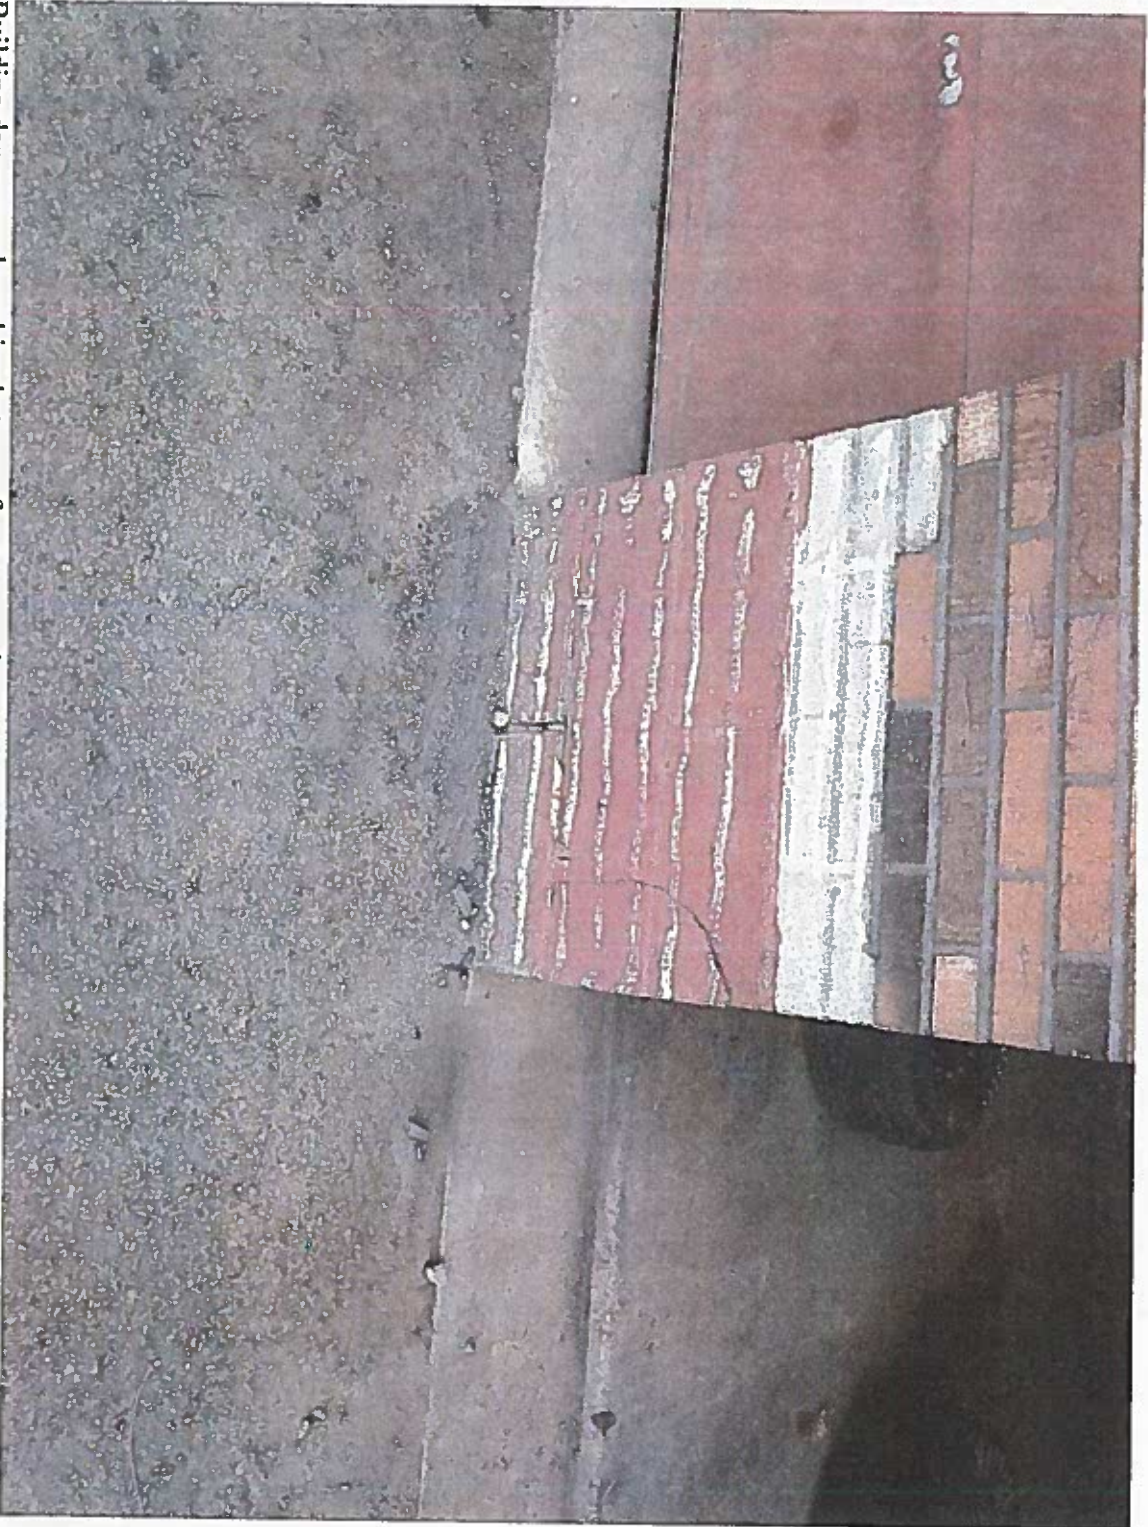
Building damage and cracking between front garage bays.

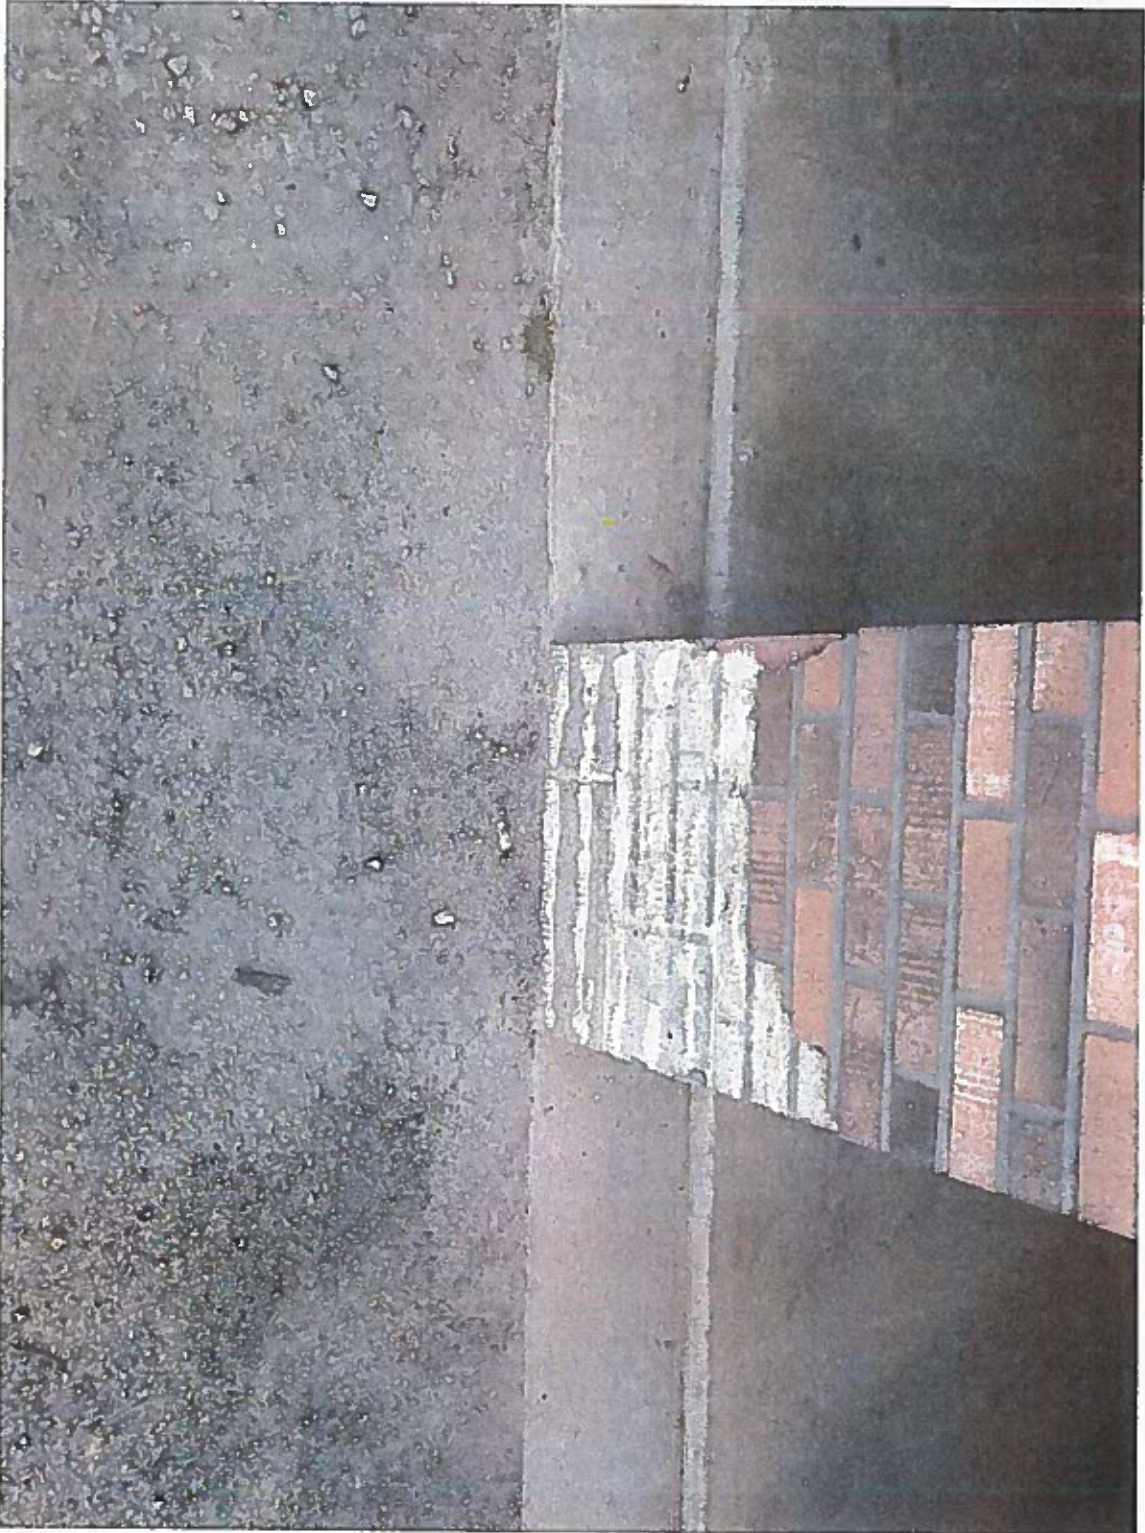
Building damage and cracking between front garage bays.

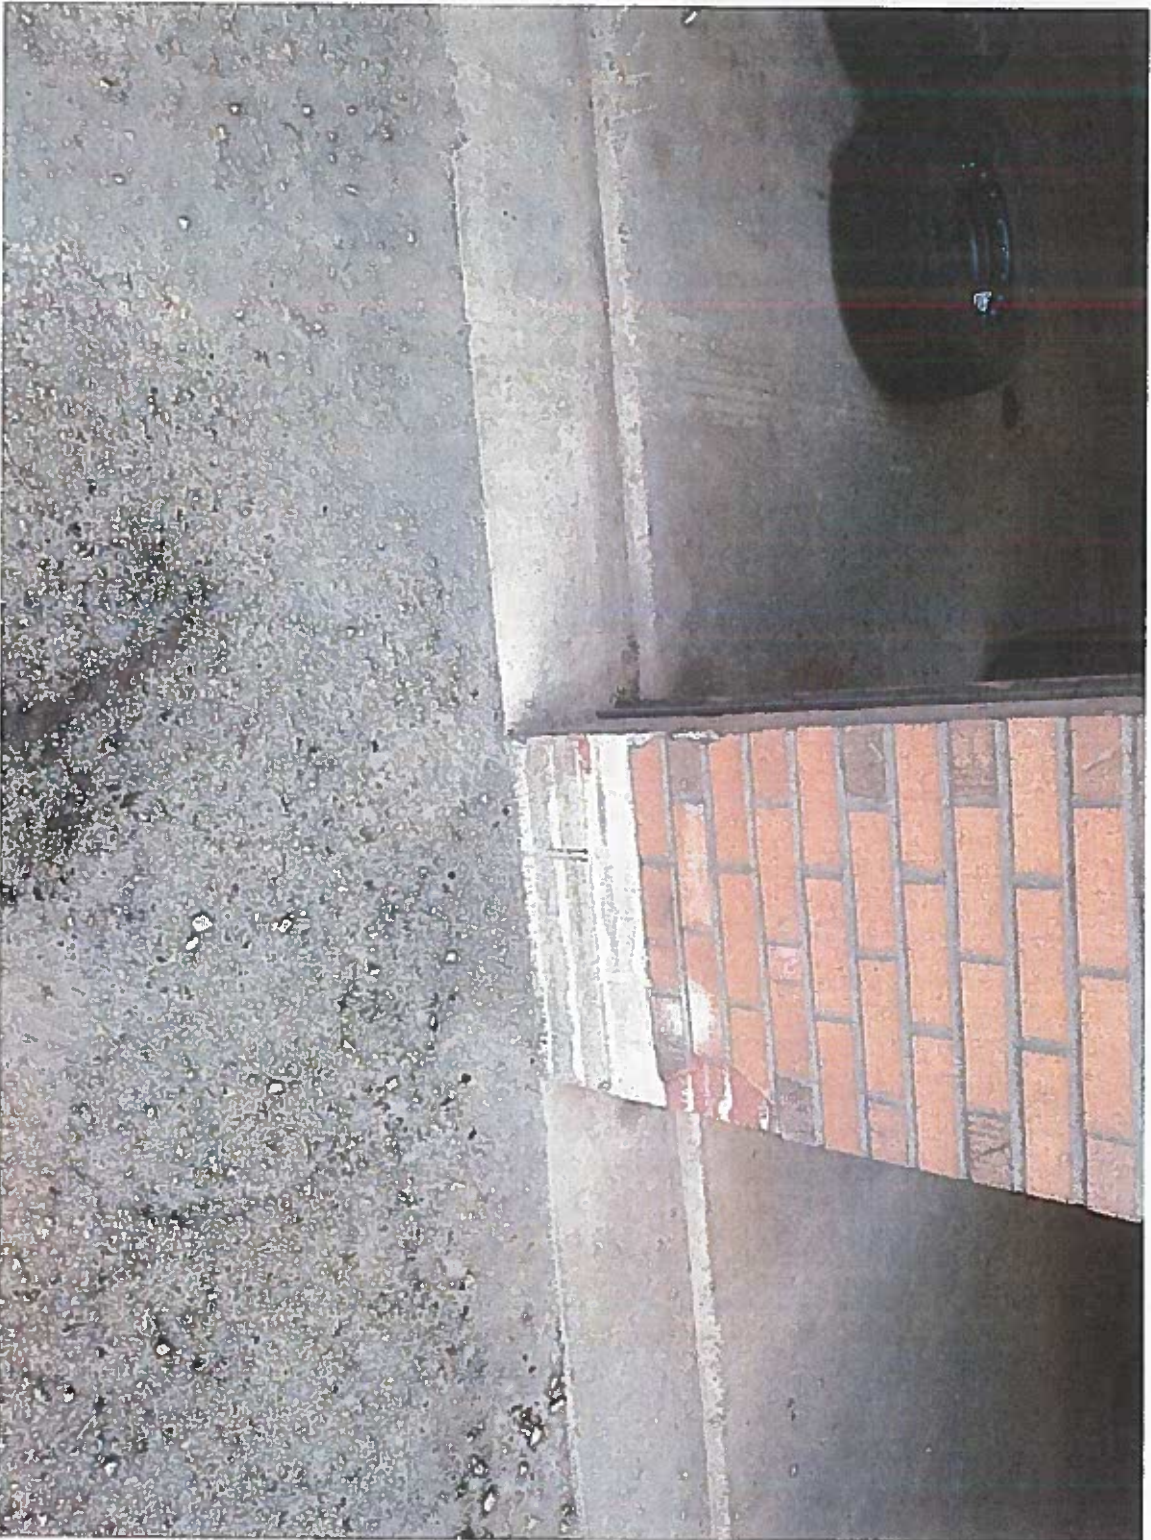
Building damage and cracking between front garage bays.

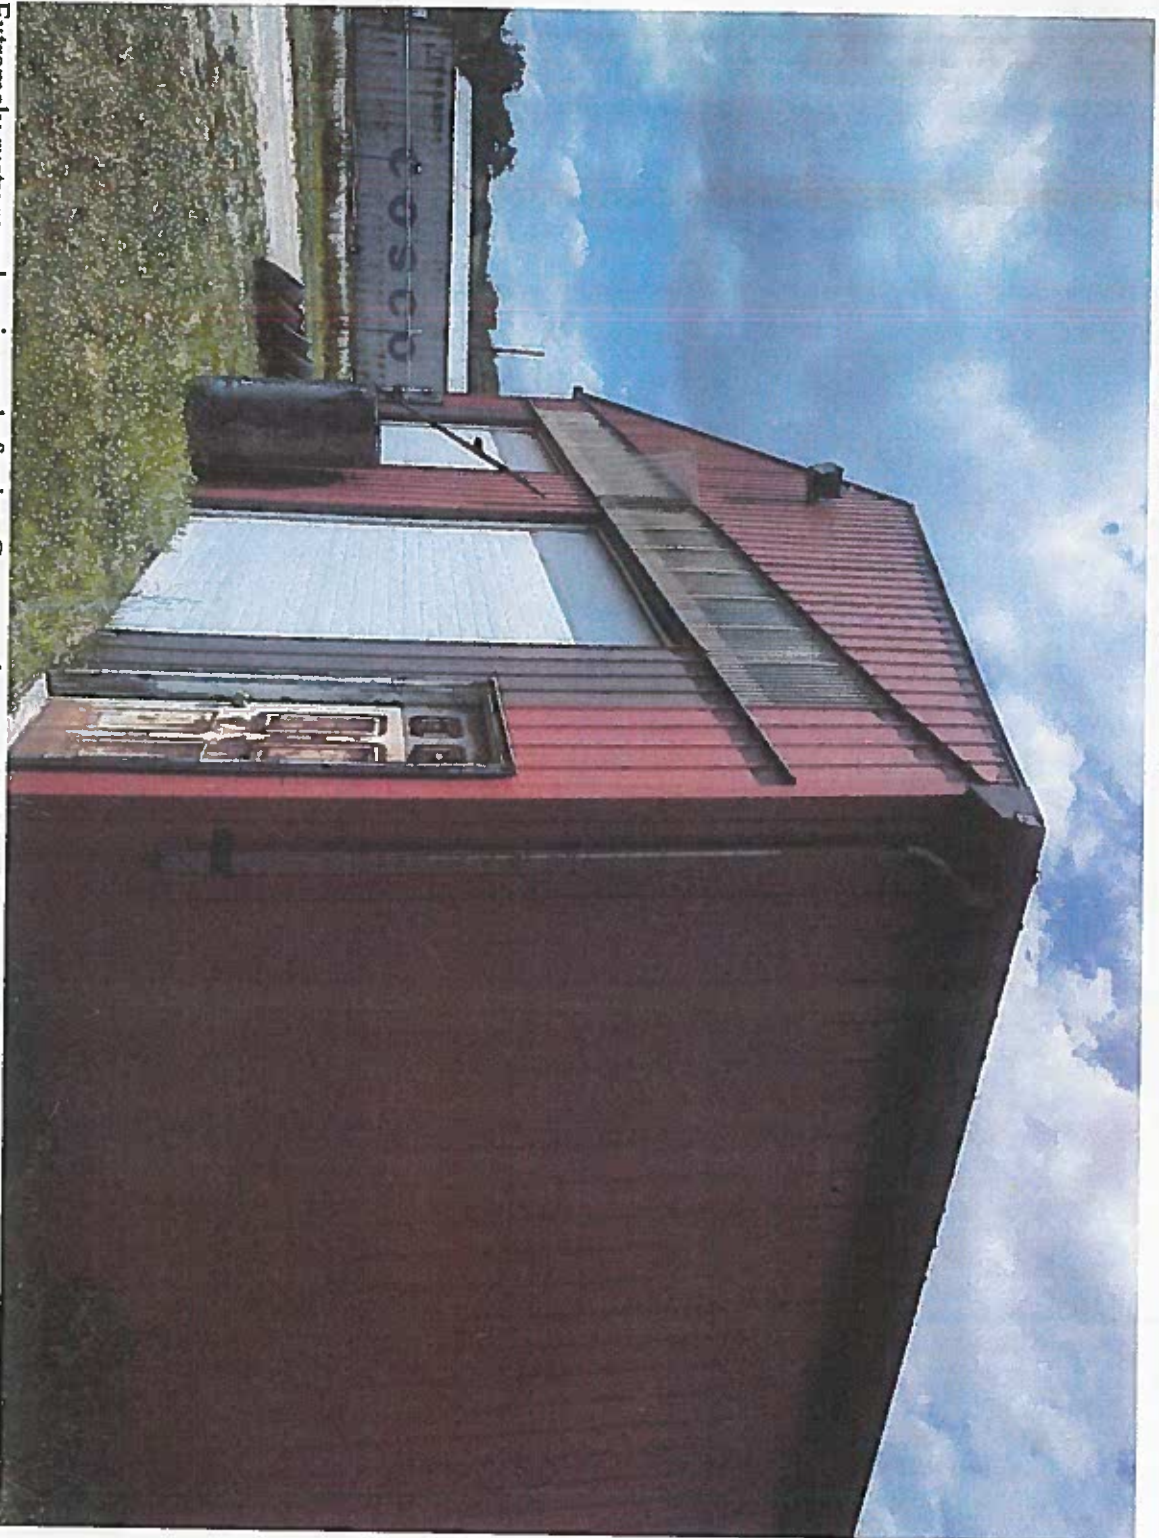
Extremely rusty rear door in need of paint. Grass needs cut. Additional views of trim pulling away above rear garage doors.
